Case History

The South East Missouri (SEMO) Hospital is located near the New Madrid Fault, where earthquakes may likely occur. Engineers were unable to design buildings using normal construction principals. Taking extra precautions to find the correct solution, which would not place the buildings at risk during earthquake conditions, Helitech's® in-house engineers in conjunction with a geotechnical firm, presented a conceptual design utilizing A.B. Chance soil screws and shotcrete.

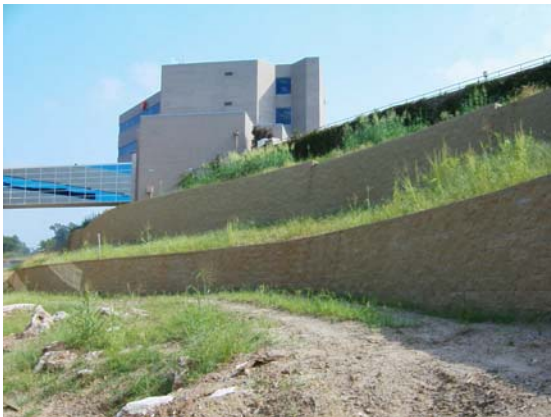
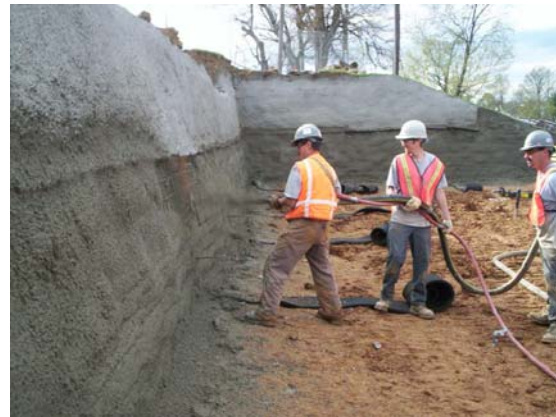
Helitech® shored the hillside in front of SEMO hospital enabling the construction of the hospital addition and garage to commence. This involved excavating the embankment in 5 to 6 foot vertical cuts. The process was broken into multiple tiers working from top to bottom, allowing construction on one tier at a time, insuring that each tier wall was installed correctly. A. B. Chance soil screws were installed horizontally into the soil for soil stabilization first, then Hydroway® drainage system was placed behind and adjacent to the wall, Helitech® then applied a four inch thick layer of concrete across the wall to prevent the soil from sloughing and being exposed to the elements.

The shotcrete earth retention wall was a cost effective and efficient method to shore the embankment. The wall was designed to take lateral forces, allowing it to be an effective solution for buildings located in a geographical area where earthquakes may likely occur.
